- Preliminary Tree Protection Plan -

## OAKVIEW

29401 State Route 507 S.  
Roy WA 98580

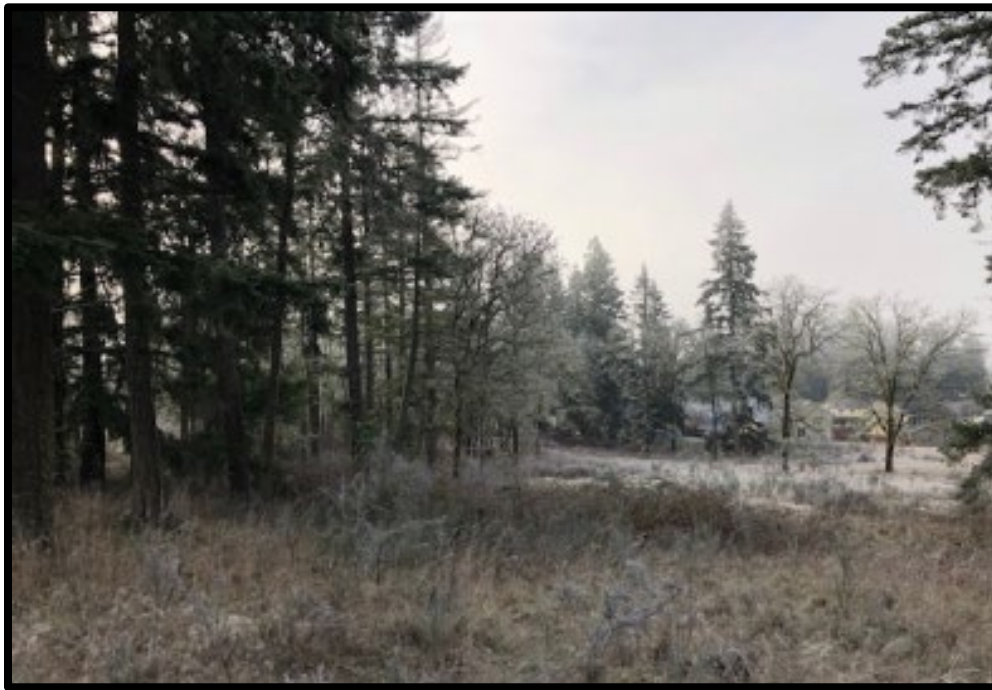
**Forest Cover Type I:** This cover type is a mostly open field with scattered individual and small groves of trees. There are 149 trees in this cover type, mostly Oregon white oaks (*Quercus garryana*) with Douglas-fir (*Pseudotsuga menziesii*) trees mixed in. Other species include black cottonwood (*Populus trichocarpa*), silver maple (*Acer saccharinum*), Oregon ash (*Fraxinus latifolia*), and western redcedar (*Thuja plicata*). Tree size ranges from 9 to 51 inches in diameter at breast height (DBH). Tree condition ranges from 'Very Poor' to 'Good,' with most trees described as being in 'Fair' condition or better. The species, diameter range, conditions, numbers and percent composition by species of trees in type I are summarized in Table 1.

Understory vegetation includes common snowberry (*Symphoricarpos albus*), Oregon-grape (*Mahonia aquifolium*), trailing blackberry (*Rubus ursinus*), ocean-spray (*Holodiscus discolor*), Indian-plum (*Oemleria cerasiformis*), woods rose (*Rosa woodsii*), and western hazel (*Corylus cornuta*). Scotch broom (*Cytisus scoparius*), bracken fern (*Pteridium aquilinum*), Himalayan blackberry (*Rubus armeniacus*), grasses and broadleaved weeds dominate the open fields.

**Photo 1.** View of Trees in Cover Type I. View looking south from interior portion of property.

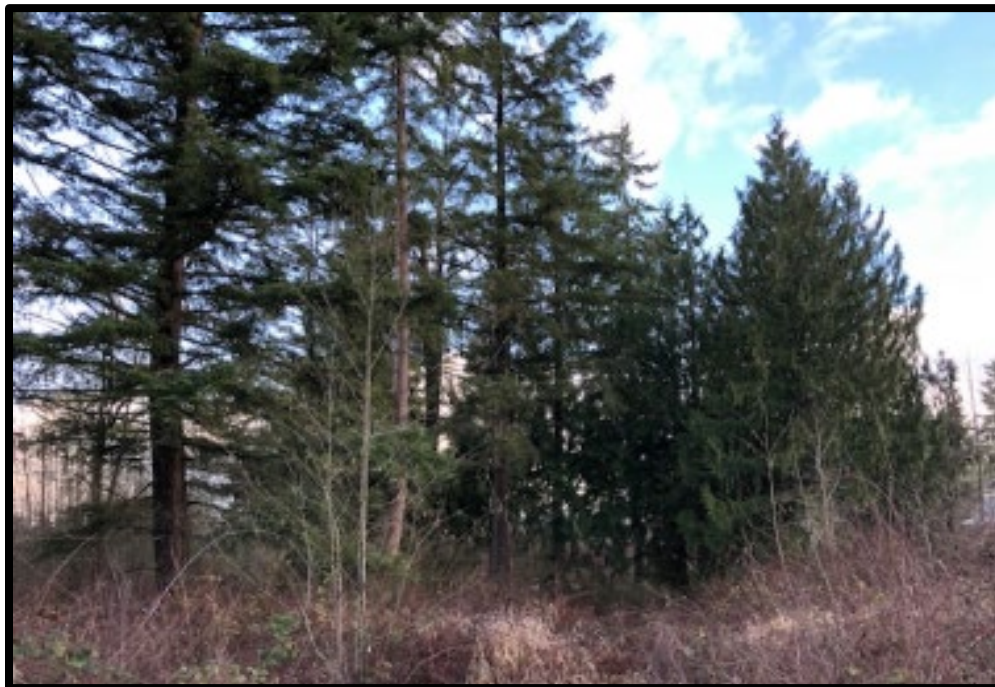
**Forest Cover Type II:** This cover type is a more contiguous, mixed-species stand of Douglas-fir, Oregon white oak, and western redcedar. Bigleaf maple (*Acer macrophyllum*), bitter cherry (*Prunus emarginata*) and black cottonwood are also present. There are 151 trees in this cover type that range in size from 9 to 52 inches in diameter at breast height (DBH). Tree condition ranges from 'Very Poor' to 'Good,' with most trees described as being in 'Fair' condition or better. The species, diameter range, conditions, numbers and percent composition by species of trees in type II are summarized in Table 2.

Understory vegetation in Cover Type II is dense and consists primarily of Himalayan blackberry and Scotch broom. Occasional native plants include trailing blackberry, Oregon-grape, ocean-spray, sword fern (*Polystichum munitum*), ocean-spray, Indian-plum, western hazel, grasses and broadleaved weeds.

**Photo 2.** View of Trees in Cover Type II. View looking west from interior portion of property.

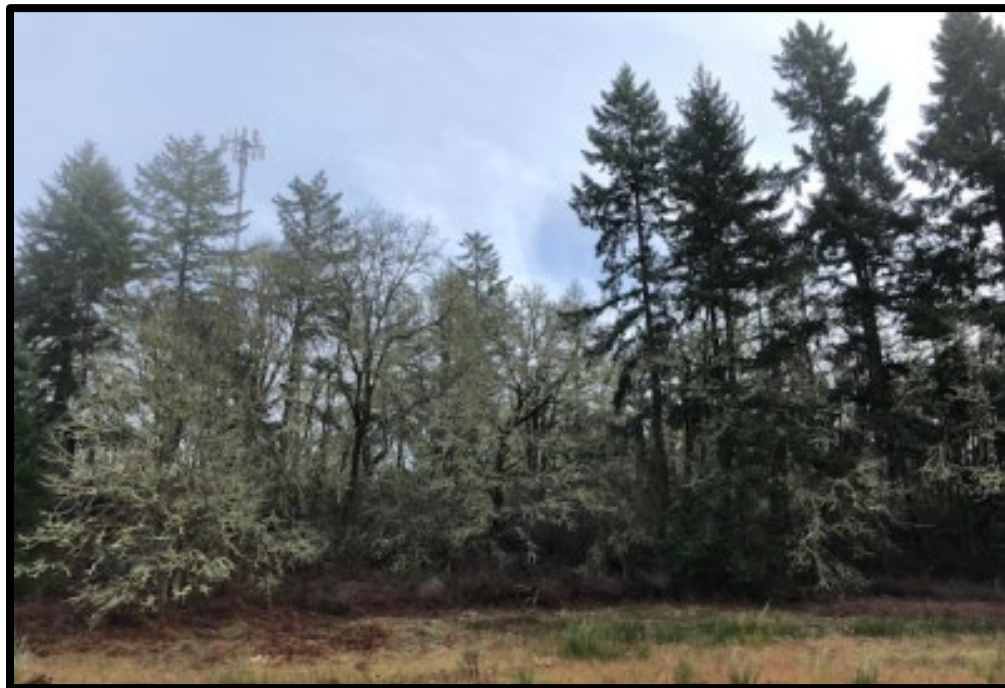
**Forest Cover Type III:** This cover type includes the contiguous 8.05-acre stand of mature Oregon white oak and Douglas-fir with a few bigleaf maple trees in the north-central portion of the project area. Trees in this cover type are generally larger than elsewhere on the site. The Oregon white oaks and Douglas-fir trees are codominant in this type and the understory vegetation is denser and more extensive, but substantially similar in composition to the vegetation in Cover Type II. Tree size ranges from 9 to 54 inches DBH. There are a projected 637 trees in this cover type that range in condition from ‘Dead’ to ‘Good.’ Dead trees were not included in the inventory. The species, diameter range, conditions, numbers and percent composition by species of trees in type III are summarized in Table 3.

**Photo 3.** View of trees in Cover Type III looking east from Cover Type I.

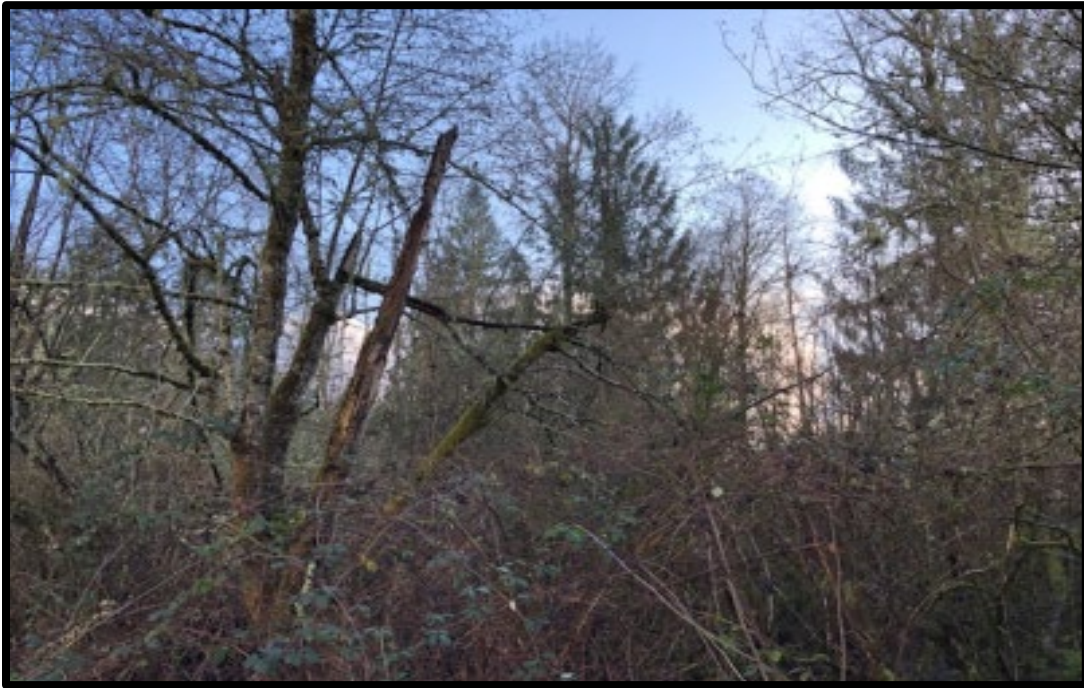
**Forest Cover Type IV:** This cover type includes the stand of trees in the wetland area. This contiguous stand of trees includes mostly red alder (*Alnus rubra*), black cottonwood and western redcedar. The trees in this stand will remain mostly undisturbed from development and were not evaluated individually. Understory vegetation in Cover Type IV includes species typical of mesic habitats such as salmonberry (*Rubus spectabilis*), horsetail (*Equisetum spp.*), sedges (*Carex spp.*), and vine maple (*Acer circinatum*). Invasive Himalayan blackberry is also present in the understory.

**Photo 4.** View of Trees in Cover Type IV. View looking south from 294<sup>th</sup> St. S.
